### **Supplement to Expert Report of Dennis Unites**

SUBJECT: Aerial Image Analysis Reports for 1936 (map), 1958, 1962, 1968, & 1971

### Uniform Image Analysis Report

Site Name: HUNTSVILLE MGP, AL

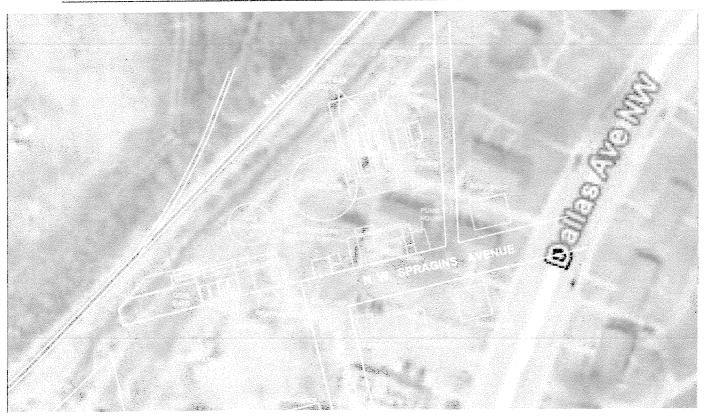
Comments: SITE HAS BEEN ENTIRELY

RAZED, GRADED AND BUILT UP INTO A

NEW NEIGHBORHOOD OF (PROBABLY) 2-

STORY DUPLEX HOMES SITUATED ALONG

MODERN, CURVINE STREETS. NO REMNANT

FEATURES OF THE FORMER MGP PLANT

REMAIN VISIBLE, ALTHOUGH ITS
EXACT FORMER LOCATION IS CLEARLY
VISIBLE FROM FEATURES ACROSS
THE GULLY AND RETRACKS TO
THE NW.
